NPS-56-80-006

COMBAT DAMAGE ASSESSMENT TEAM
A-10/GAU-8 LOW ANGLE FIRINGS
VERSUS
SIMULATED SOVIET TANK COMPANY (ARRAY 20)
(AEROJET LOT NUMBER AJD 79A181-001)
(19 SEPTEMBER 1979)
R.H.S. STOLFI
R.R. McEACHIN

MAY 1980

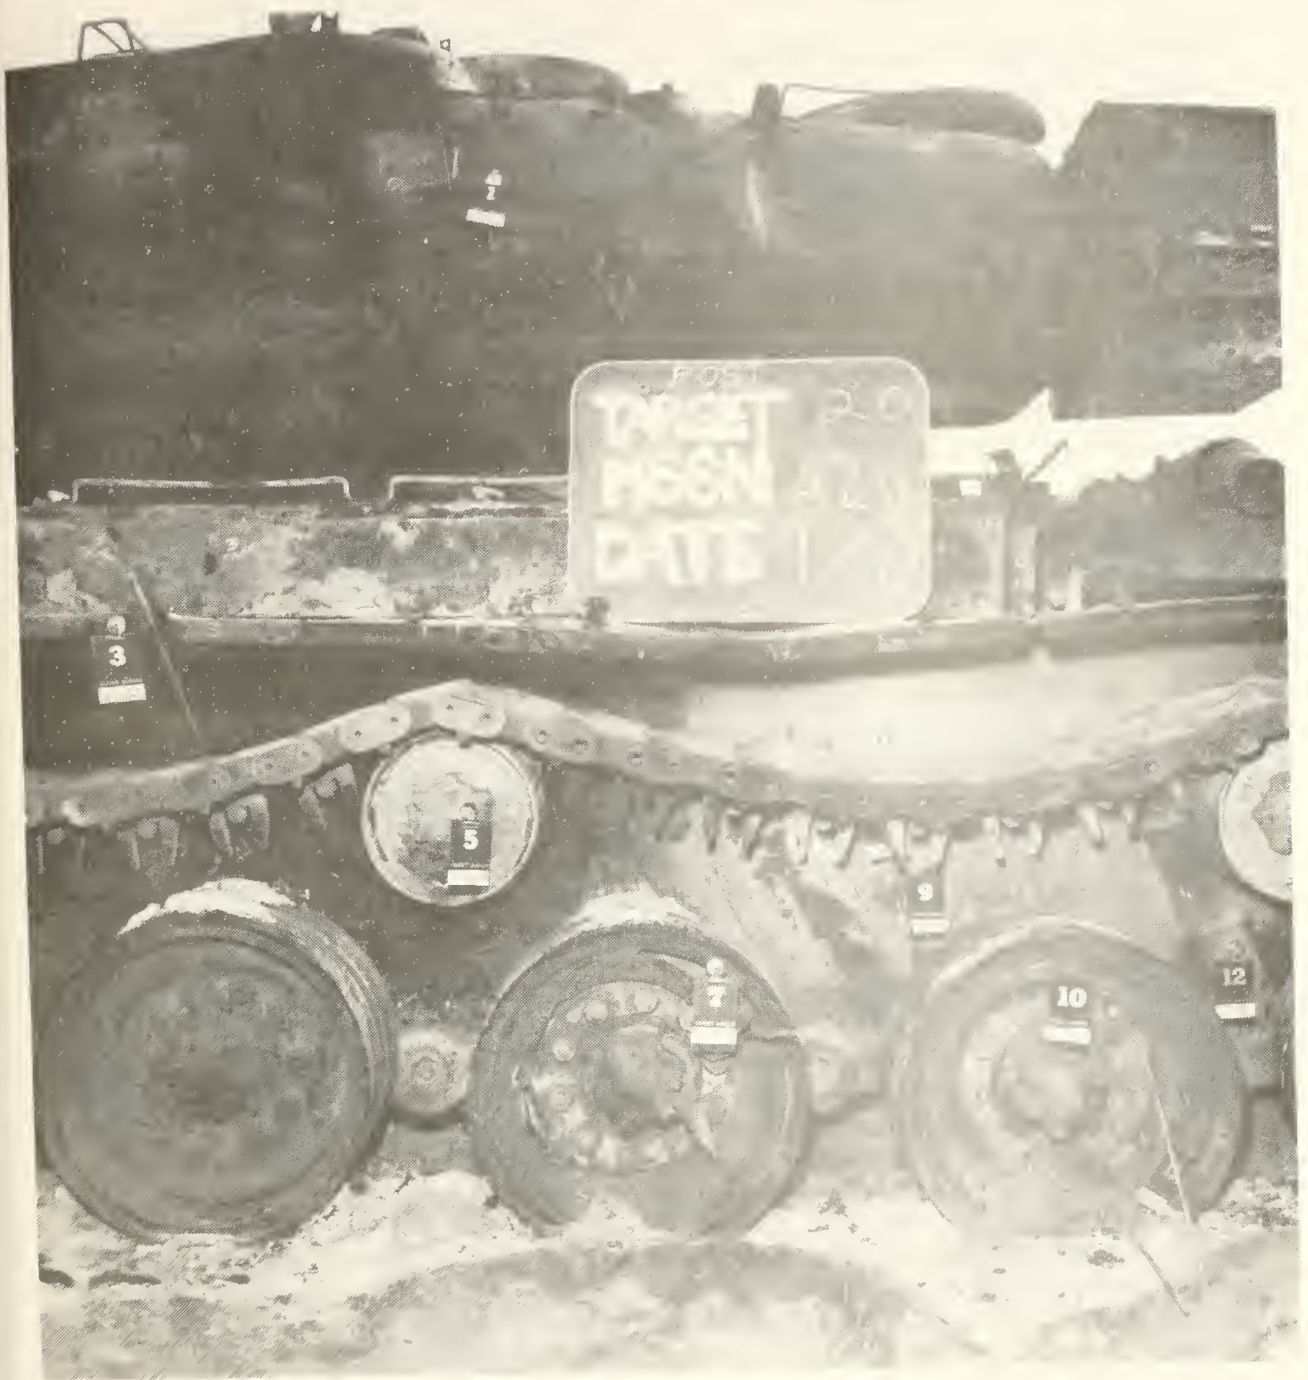
FIGURE 40. Probable Crew Casualties were caused by Impact 1 which Perforated the Turret, Tank 20.
